DISCOVERY BAY WOMEN'S CLUB

# ENGINEERING EVALUATION

**LARGE ON-SITE SEWAGE SYSTEM (LOSS)**  
(LOSS System I.D. No. JEF002)

August 22<sup>nd</sup>, 2025

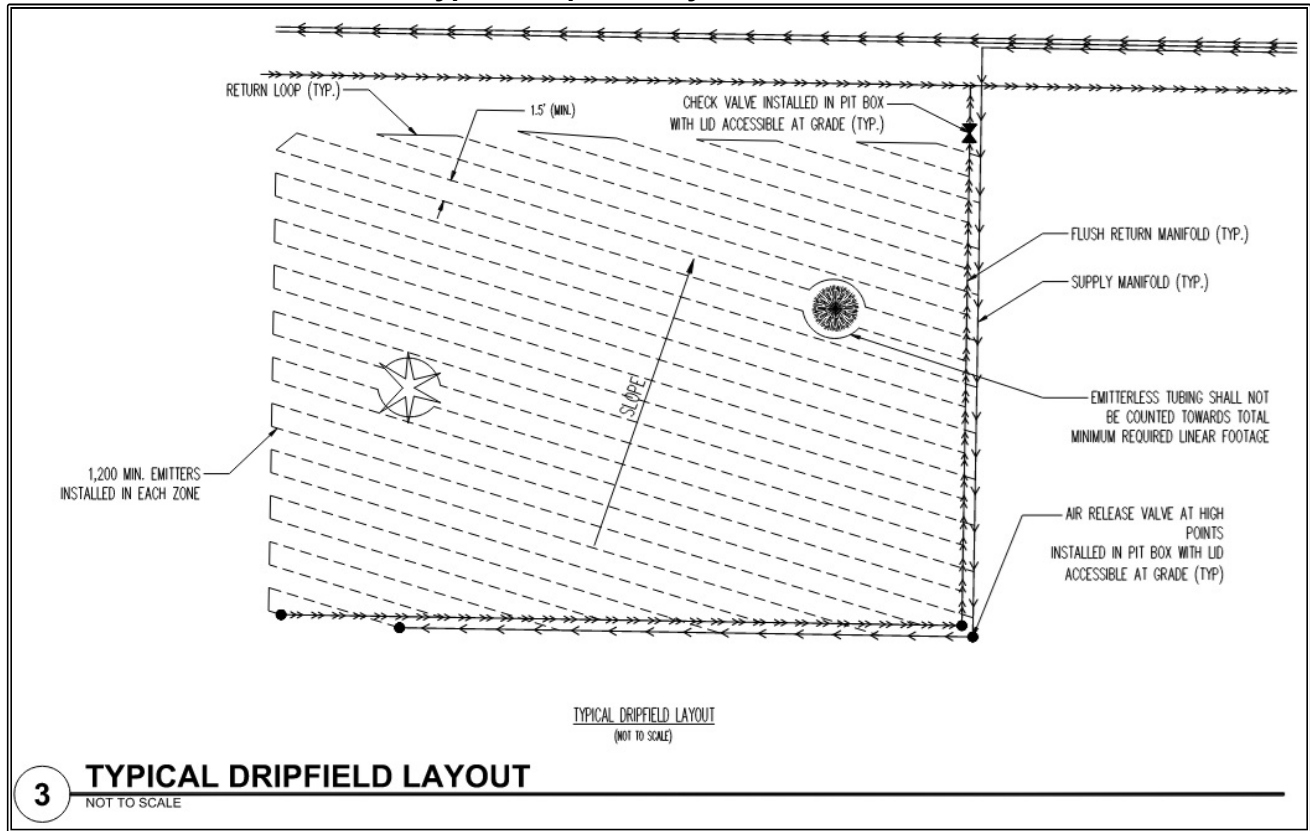
### Sheet OS2.05 – Detail No. 3 – Typical Dripfield Layout:

The primary cause of failure was found to be a significant design error as shown in the "Typical Dripfield Layout" – Detail No. 3 – in the LOSS Repair Record Drawings (presented on the following page).

This detail has long zone Supply and Return Manifolds running up the slope from bottom to top of the zone. Another detail – Detail #2 on Sheet OS2.04 – shows both the Supply and Return Manifold size as 2"Ø. Without Supply Manifold check valves between every dripline lateral, or every few dripline laterals, and without dripline lateral check valves at the ends of the laterals just before they connect to the Return Manifold, the entire dripfield zone will drain down to the bottom of the zone after the pump shuts off, causing low-end overloading, or low-end drainage. In addition, when the pump starts pumping, the zone fills from the bottom up, so the lowest laterals are being filled (and dosing) first.

During the May 27<sup>th</sup>, 2025 site visit, it was observed that the bottom 1/3 of Zones 4, 5, and 6 were the areas that were failing. There was no failure (ground saturation or ponding) within the top 2/3s of those zones. **The failure is clearly primarily from low-end overloading.**

Aqueous Solutions Engineering is recommending the replacement of the failed SDS drainfield with a trench-type pressure drainfield. A trench-type drainfield will allow deeper installation of the infiltrative surface, deeper than what has already been disturbed with the SDS installation. The bottom of the trenches will be able to be installed into native, mostly undisturbed soil.

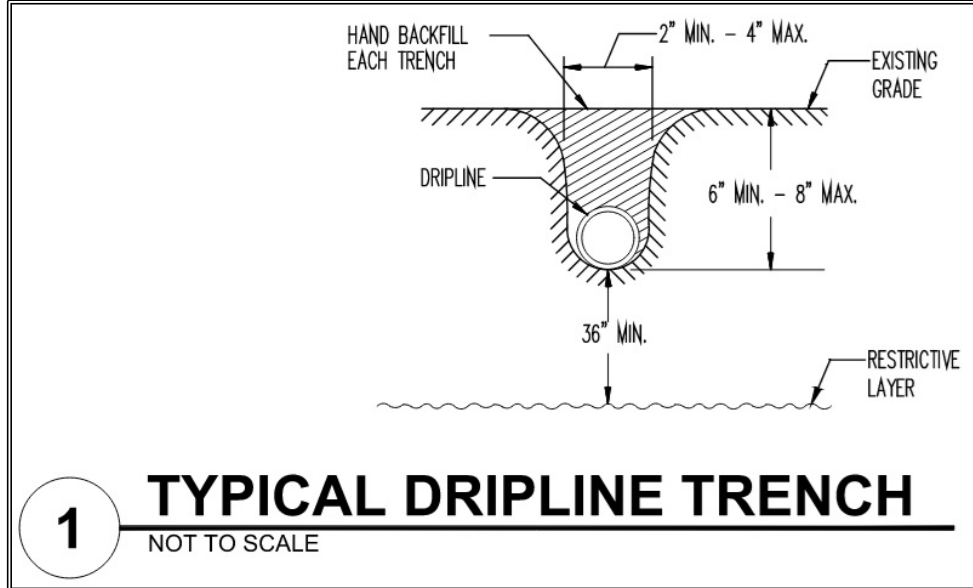
Other design issues were noted in the LOSS Repair Record Drawings. Detail #1 on Sheet OS2.04 shows a typical dripline trench:

The Netafim™ Bioline Dripline has an outside diameter of almost  $\frac{3}{4}$ ". With the detail above, this would mean that the cover over the top of the dripline would only be 5-1/4" to 7-1/4". This is shallower cover than the minimum dripline cover requirements as specified in WAC 246-272B (LOSS Code) and shallower than what is typically recommended.

During the May 27<sup>th</sup>, 2025 site visit, Aqueous discovered a failed area of dripline that had a small section of dripline with only 1-1/2 inches of cover, while other sections nearby had 6" to more than 8" of cover (but were still failing). Inadequate cover will also allow effluent to surface, however these failure spots would generally be localized. Regardless, based on the Jefferson County lowland frost depth of 12 inches, requirements and recommendations in WAC 246-272B and the Netafim<sup>TM</sup> design manual, the driplines should have been designed with a minimum of 8 inches of cover, with a preferred cover of 12 inches based on frost depth.

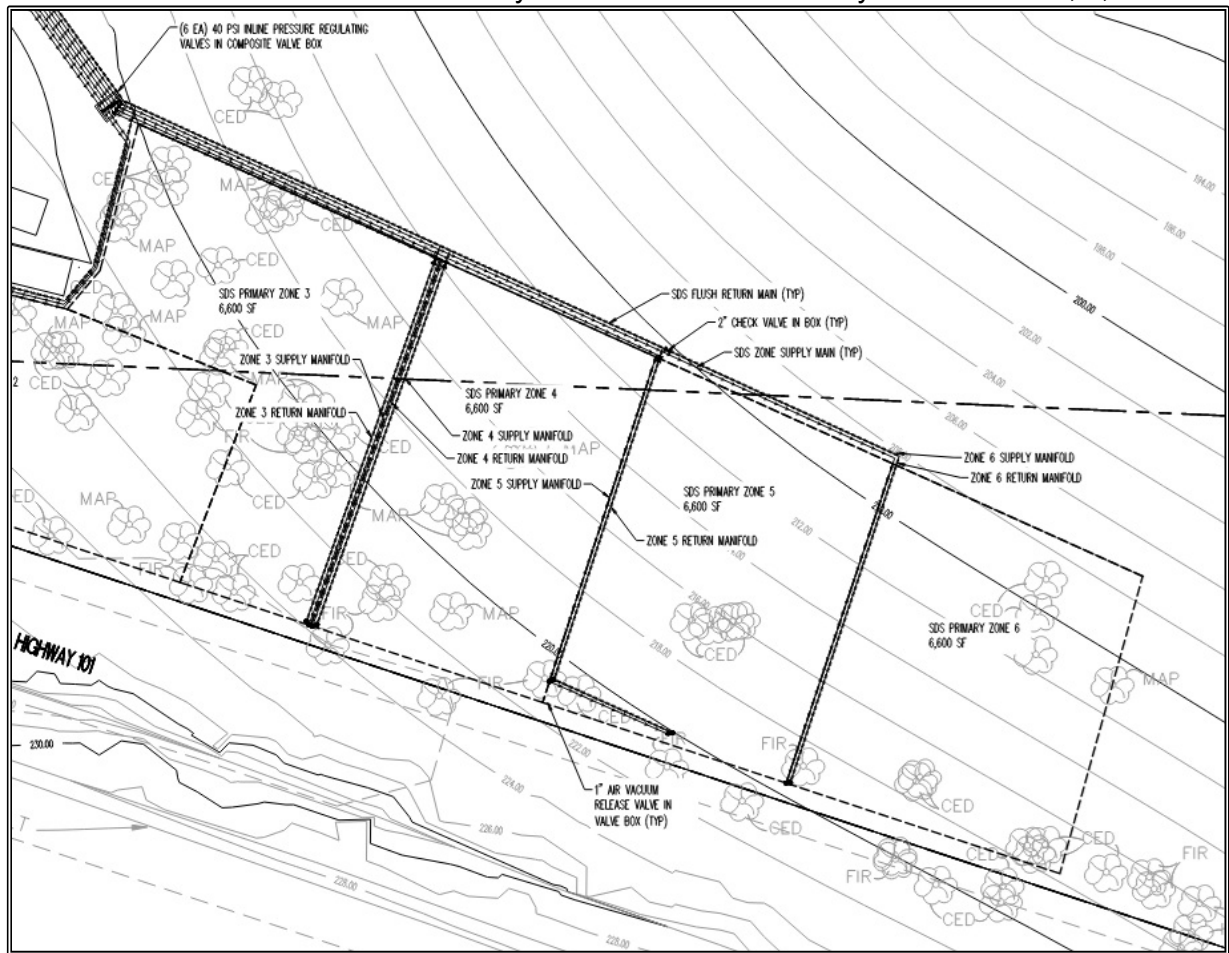
Sheet OS1.02 shows narrower zone layouts relative to contour layout for Zones 4, 5, & 6:

The design layout of Zones 4, 5, 6, and a portion of Zone 3, as shown on Sheet OS1.02 of the LOSS Repair Record Drawings, has the zone configuration narrower down the slope, requiring many more rows of dripline laterals:

As stated in the Netafim™ design manual, “The bunching of laterals increases the number of rows needed and increases the chance of saturation at the base of the slope.”

This could also be contributing to the drainfield failure of these three zones.
