## Discovery Bay Women's Club Sequim, WA

Report #: 8592-17  
Beginning: January 1, 2026  
Expires: December 31, 2026

## RESERVE STUDY Update "With-Site-Visit"

July 30, 2025

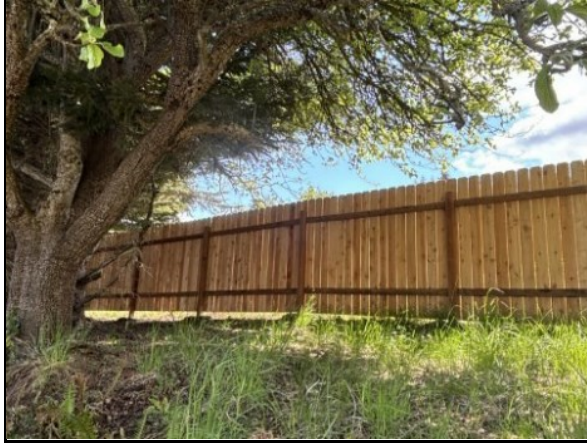
Factored here is funding for replacement due to typical deterioration that occurs of these wood surfaces in exposed areas. Regular sealer applications as maintenance project will help to extend life and maintain appearance; we assume funded out of operating budget. In our experience, quality solid-bodied stain yields best result. Remove contact with ground and surrounding landscape, avoid sprinkler patterns.

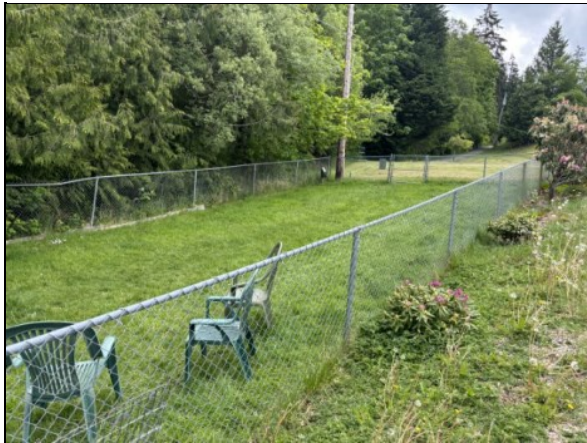
For financial planning purposes due to typical deterioration that will occur over time, factored here is replacement at roughly the time frame shown below. Evaluate fence as remaining useful life approaches zero years and adjust life accordingly. Chain link fencing is generally a low maintenance item. Inspect periodically and repair as needed. If corrosion is observed, apply rust inhibitor to prevent corrosion from decreasing the useful life.

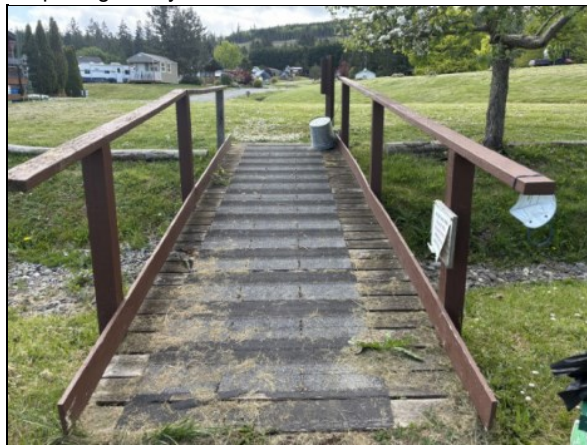
**Comp #: 107 Stairs at 1st St. - Rpr/Replace****Approx Quantity: 1 wood staircase****Location:** From 1st Street down to lots**Funded?:** Yes.**History:** No major projects known**Comments:** No major damage/deterioration noted of wood staircase and railings. The open boards allow water to drain between them.

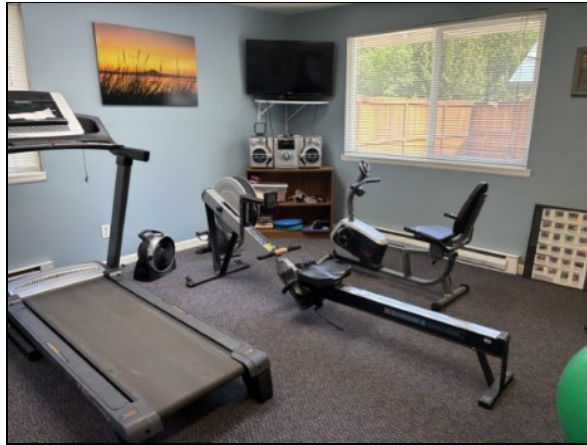
**Comp #: 403 Workout Equipment - Repair/Replace****Approx Quantity: 4 cardio pieces****Location:** Within laundry room building at exercise room**Funded?:** No. No plans for replacement within reserves; replace individually or donations**History:** Unknown**Comments:** There are two treadmills, an exercise bike and rowing machine. No problems reported with this equipment. We assume can be repaired/replaced individually as needed out of the operating budget with no anticipation for comprehensive replacement meriting reserves.**Useful Life:****Remaining Life:**

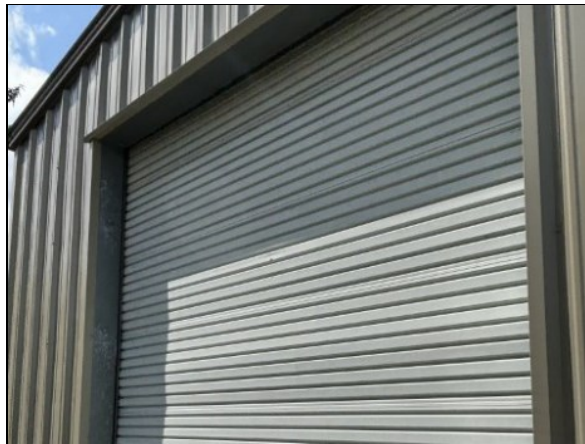
**Comp #: 532 Tool Shop Rollup Door - Replace****Approx Quantity: 1 8' x 12' metal****Location:** Maintenance building**Funded?:** No. No predictable replacement; replace with building**History:** Building installed 2011**Comments:** Some local dents of metal door, however no widespread or major damage known. Assumed to be opened / closed infrequently. This door will be replaced along with overall larger building replacement (#530), with no separate replacement anticipated.**Useful Life:****Remaining Life:**

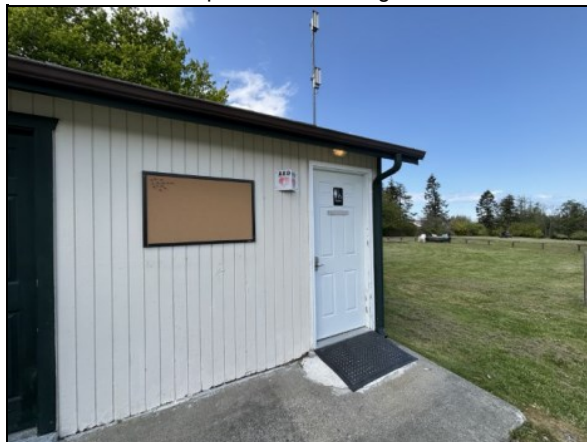
**Comp #: 551 Lower Restroom Bldg - Replace****Approx Quantity: 400 GSF wood structure****Location:** Rooftop of restroom**Funded?:** No.**History:** Replaced in 2014**Comments:** The age of this structure is thought to be about circa 1973. The roof was replaced in 2014 with standing seam metal. Siding/exterior materials utilized are typical of that era (wood panel material) - site built on slab foundation. Prior reserve studies had factored complete replacement of the building per the direction of the Board of Directors. As this building is not a manufactured structure, service to the community can be extended for many years with periodic component replacement (#552). Complete replacement of this structure is not included for reserve funding as it is inappropriate to include lifetime components, unpredictable expenses (such as damage due to fire, flood, or earthquake), and expenses more appropriately handled from the Operational Budget or as an insured loss. No total replacement funding therefore factored in this report.**Useful Life:****Remaining Life:**

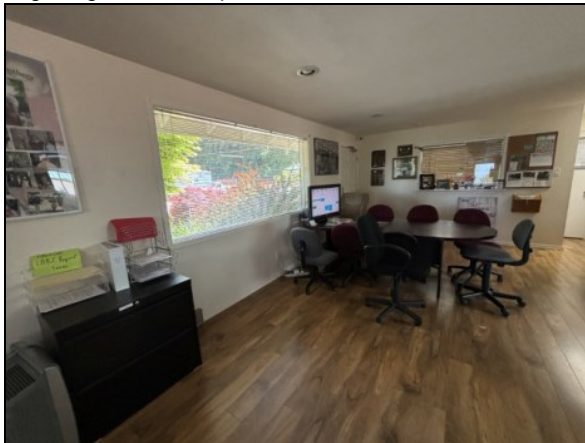
**Comp #: 705 Office/Lounge Conference Tables****Approx Quantity: 3 tables (6) chairs****Location:** Office / lounge area**Funded?:** No. Assumed to be operating funding not Reserves**History:** Unknown**Comments:** No major damage/wear to these furnishings. Association reported to us in previous update, these furnishings can be replaced within the annual operating budget, not anticipated as reserve item.**Useful Life:****Remaining Life:**

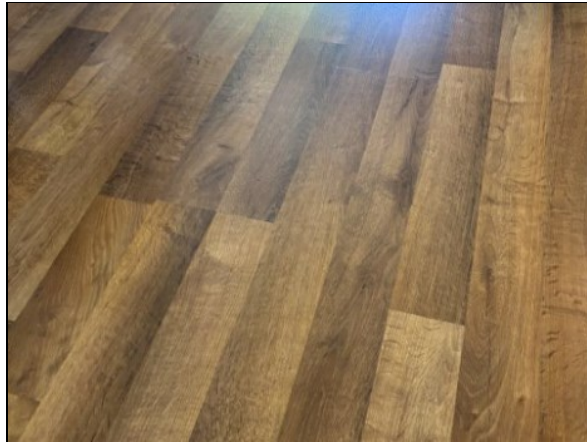
**Comp #: 720 Lodge (Radclyffe) Flooring, Paint****Approx Quantity: 1,120 square feet****Location:** Interior of Radclyffe Lodge manufactured unit**Funded?:** No. This component not funded as replacement of structure funded within #520 in 2018**History:** Unknown**Comments:** With eventual replacement of entire structure anticipated (see component #520), replacement funding not included as cost will be included in overall replacement cost. Once new structure is in place, include funding as appropriate for type and quantity of flooring for cyclical funding.**Useful Life:****Remaining Life:**

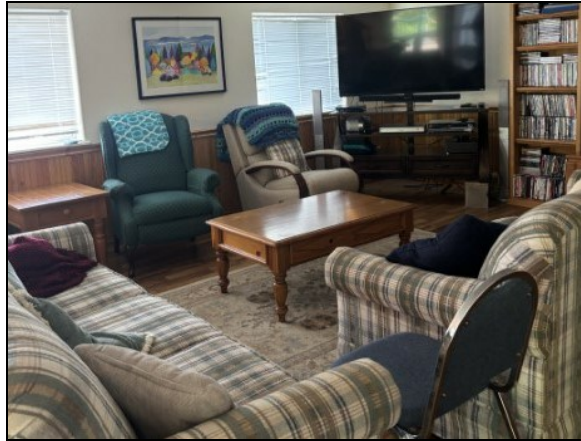
**Comp #: 721 Radclyffe Furniture/ Décor -Replace****Approx Quantity: 1 Assorted furniture****Location:** Interior of lodge building**Funded?:** No. This component not funded as replacement of structure funded within #520**History:** Unknown**Comments:** Varying age and condition with no major problems noted at the time of our inspection. At this time we are not including funding for replacement, as assumed cost of replacement included within #520 . Once replaced, assess quantity, type, etc. and include cyclical funding. Some furnishings replaced with donated items in the past.**Useful Life:****Remaining Life:**

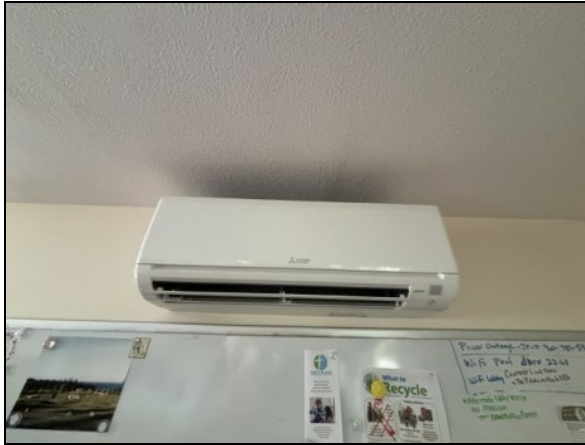
**Comp #: 760 Building Interiors - Paint****Approx Quantity: 1 Numerous buildings****Location:** Interior walls, ceilings, etc.**Funded?:** No. History of on-site staff completing interior paint with reserve funding not needed**History:** Varies**Comments:** Some local fading/wear, but not widespread at this time. The Association history has been interior painting if completed by on-site staff and no history of utilizing reserve funds. Funding removed from the reserve study based on successful completion of interior painting outside reserves.**Useful Life:****Remaining Life:**

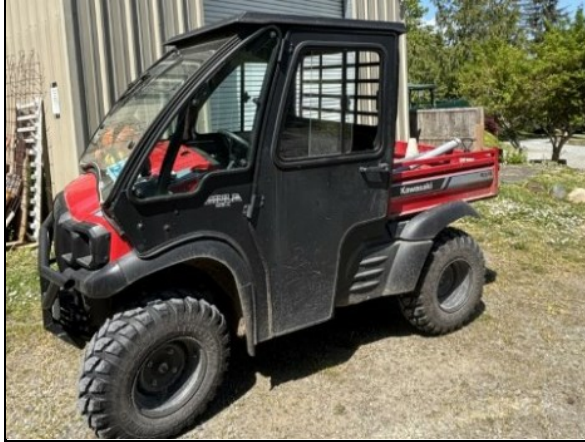
**Comp #: 949 Kawasaki Mule - Replace****Approx Quantity: 1 4X4 utility vehicle, 2023****Location:** On-site**Funded?:** Yes.**History:** Replaced in April 2024 (2023 model) at \$18,956**Comments:** Purchased in 2024. No problems reported. Factored is replacement. Have serviced as part of annual operating budget.**Useful Life:**  
12 years**Remaining Life:**  
10 years

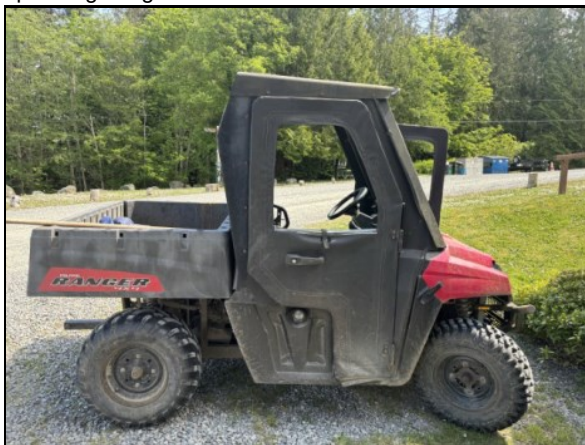
**Comp #: 950 Polaris Ranger - Replace****Approx Quantity: 1 Utility vehicle****Location:** Parked near Garden Shop during our July 2019 site visit**Funded?:** Yes.**History:** Purchased in 2011**Comments:** As previously reported, no problems at this time; purchased 2011, replacing Dodge truck. Factored is replacement. Have serviced as part of annual operating budget.**Useful Life:**  
12 years**Remaining Life:**  
2 years
