DISCOVERY BAY WOMEN'S CLUB

# ENGINEERING EVALUATION

**LARGE ON-SITE SEWAGE SYSTEM (LOSS)**  
(LOSS System I.D. No. JEF002)

August 22<sup>nd</sup>, 2025

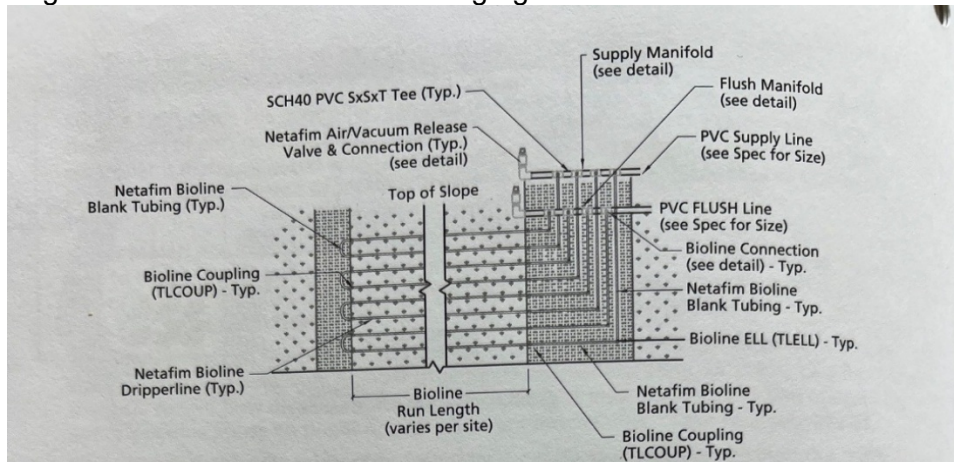
**Figure 13 - "Top Feed" Same Side Supply and Flush Manifolds for Slope Layouts**

This patented "Top Feed" layout can only be used with Netafim Bioline dripperline. Top feed layouts are popular when working on slopes because they lessen the drainage. This layout is using same side supply and flush manifolds.

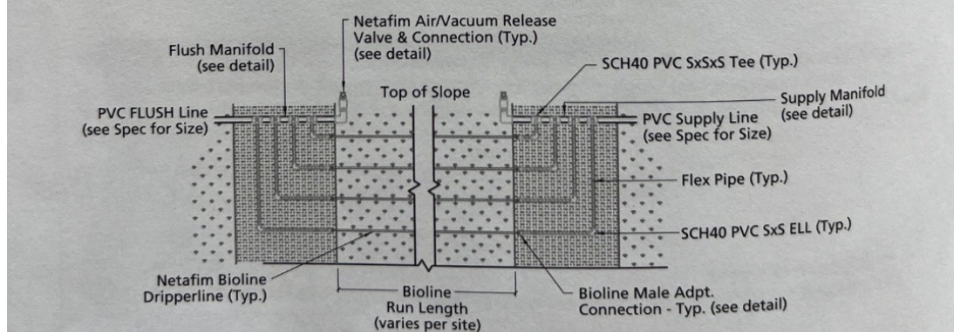
**Figure 14 - "Top Feed" Opposite Side Supply and Flush Manifolds for Slope Layouts**

This is an opposite side supply and flush manifold version of the patented top-feed layout that can only be used with Netafim Bioline dripperline.

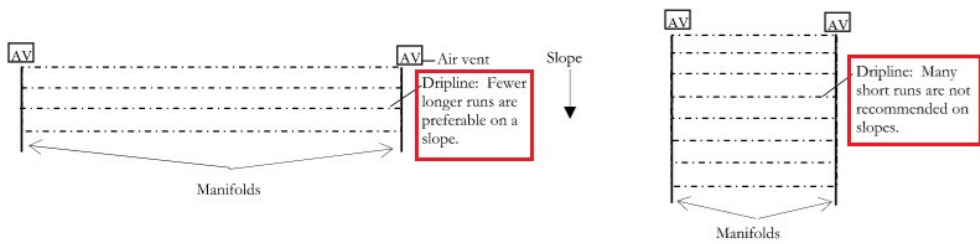
Concentrate drip lines at the top of the hill with wider spacing towards the bottom. In the case of compound slopes consult a professional irrigation designer or engineer.

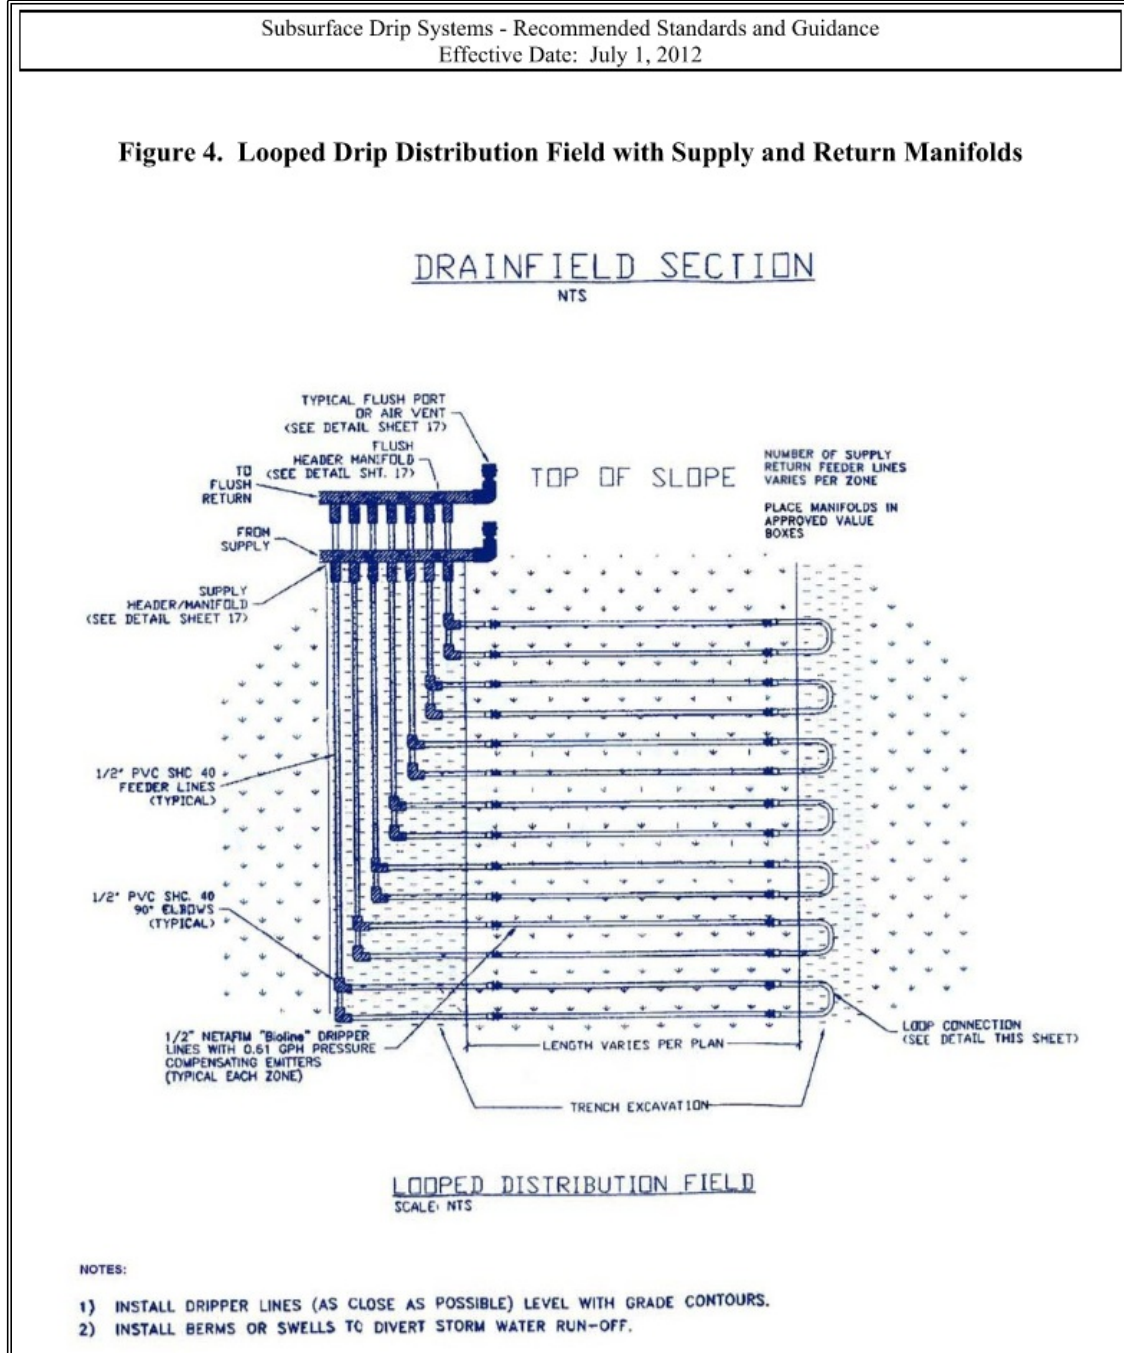
Page 34 of the July 2012 SDS RS&Gs

The problem can be solved in a number of ways. Transport and manifold piping should always be installed up gradient from dripline (see Pressure Distribution RS&G Figure 3B for example). Earthen dams can be constructed where dripline connects to the manifold or transport piping to prevent passage of effluent. Select dripline with the lowest available discharge rate (currently 0.5 and 0.6 GPH) in fine textured soils. Design drip systems to dose frequently (see Design Standards and Tables in Appendix A for minimum dose frequency for each soil type). Pump run times should not exceed manufacturer's recommendations for the soil type and designers should consider the volume of effluent that drains between doses. Select an installation technique and follow manufacturer's instructions to minimize smearing. Consult knowledgeable dripline installers for other hints.

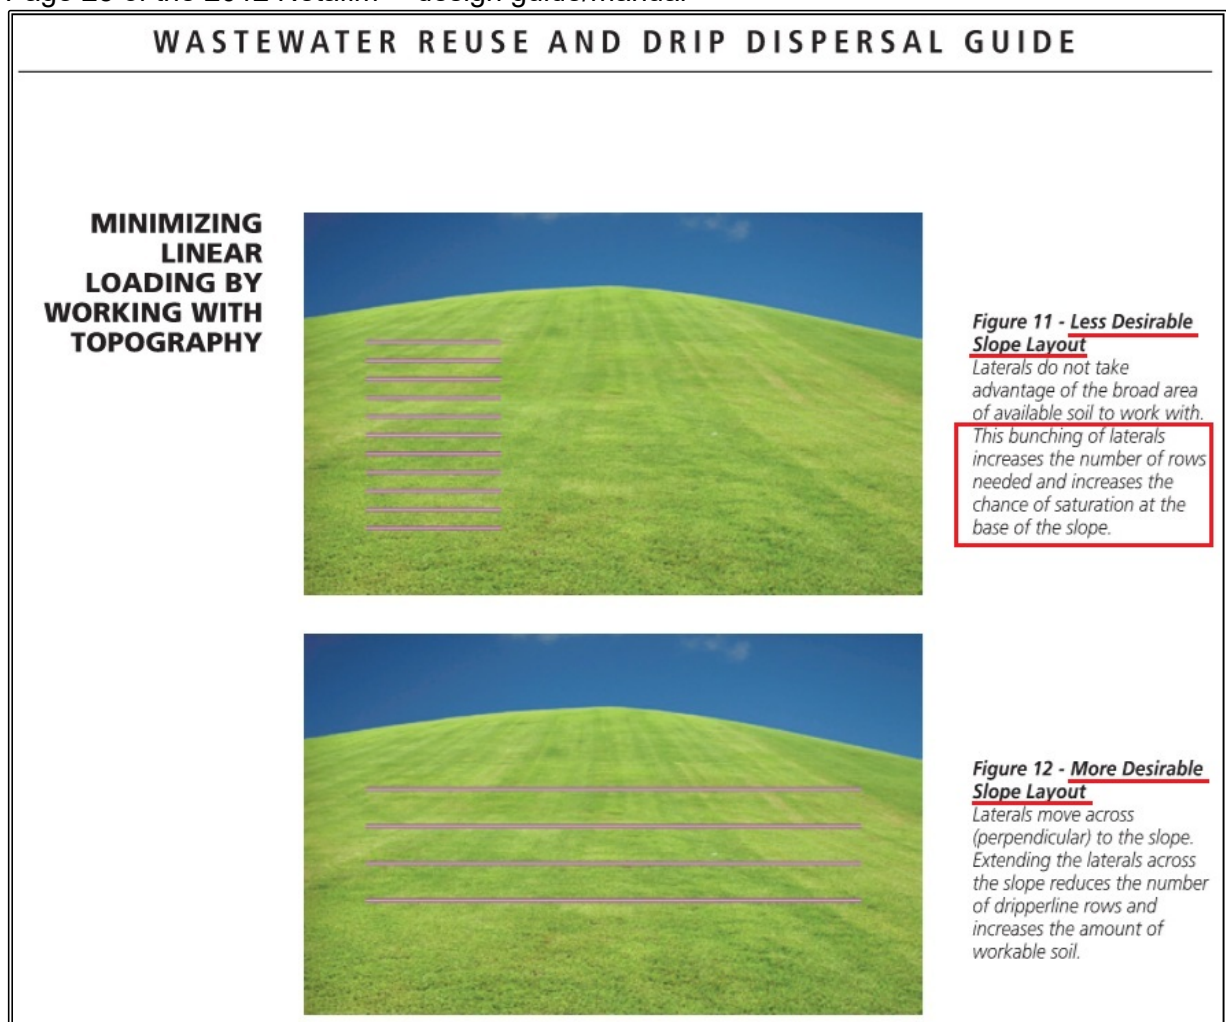
Page 25 of the 2012 Netafim<sup>TM</sup> design guide/manual

Another potential design issue is the layout of zones and driplines in a narrower configuration on the slope versus a preferred (and manufacturer-recommended) wide layout. A narrow layout of laterals relative to slope contours increases the number of dripline rows needed and increases the potential for "linear loading" and effluent breakout. The Netafim<sup>TM</sup> design manual addresses this narrow versus wide layout configuration:
