## Discovery Bay Women's Club Sequim, WA

Report #: 8592-17  
Beginning: January 1, 2026  
Expires: December 31, 2026

## RESERVE STUDY Update "With-Site-Visit"

July 30, 2025

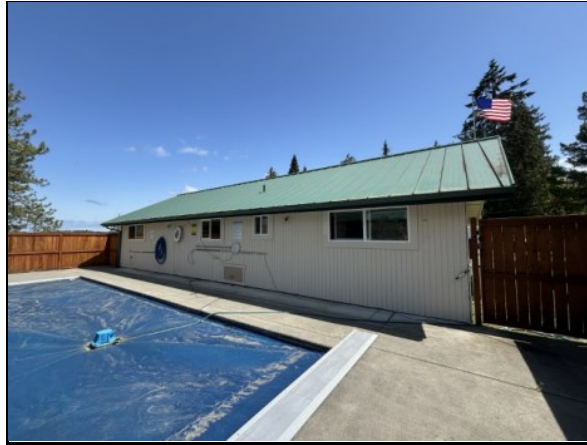
Siding/exterior materials utilized are typical of that era - site built on slab foundation. Prior reserve studies had factored complete replacement of the building per the direction of the Board of Directors. As this building is not a manufactured structure, service to the community can be extended for many years with periodic component replacement (see #501 & #502). Complete replacement of this structure is not included for reserve funding as it is inappropriate to include lifetime components, unpredictable expenses (such as damage due to fire, flood, or earthquake), and expenses more appropriately handled from the Operational Budget or as an insured loss. No total replacement funding therefore factored in this report.

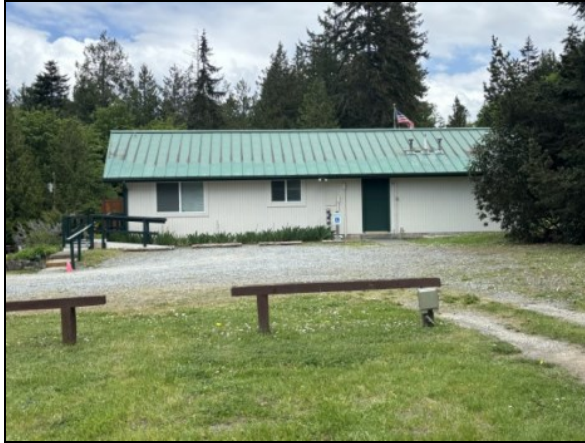
Siding/exterior materials utilized are typical of that era - site built on slab foundation. Prior reserve studies had factored complete replacement of the building per the direction of the Board of Directors. As this building is not a manufactured structure, service to the community can be extended for many years with periodic component replacement (see #511 & #512). Complete replacement of this structure is not included for reserve funding as it is inappropriate to include lifetime components, unpredictable expenses (such as damage due to fire, flood, or earthquake), and expenses more appropriately handled from the Operational Budget or as an insured loss. No total replacement funding therefore factored in this report.

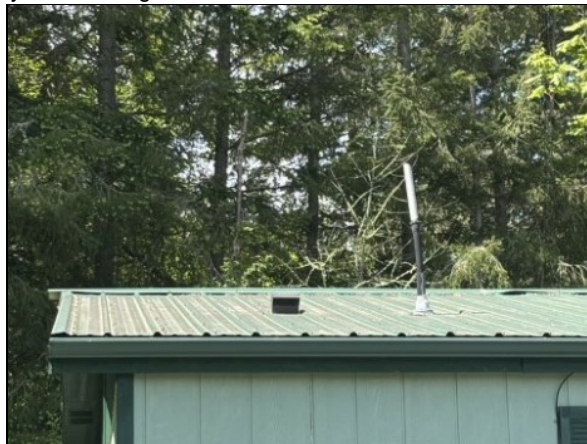
**Comments:** Standing seam metal roof installed in 2006. This installation should last for the remaining life of the structure (#520) assuming replacement of structure timing followed in that component. When new structure installed, that roof may need to be included in future reserve study updates when material type and estimated life is established. No basis for reserve funding at this time. Inspect current roof routinely to ensure tight seams, fasteners, etc.

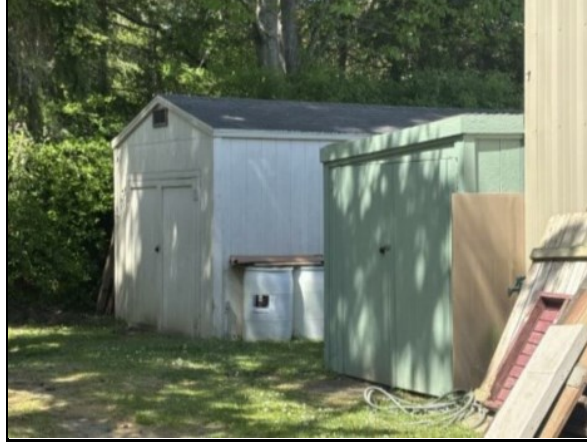
**Comp #: 535 Tractor Garage - Replace****Approx Quantity: 2 200 SF (10X20)****Location:** Behind tool shop**Funded?:** Yes.**History:** Installed bout 2007**Comments:** Panel wood siding and metal roofing with some local dirt/grime, however no widespread or significant damage noted.

Factored is funding for roughly thirty year service life before replacement is warranted. Paint and repair as needed using general operating/maintenance funds.

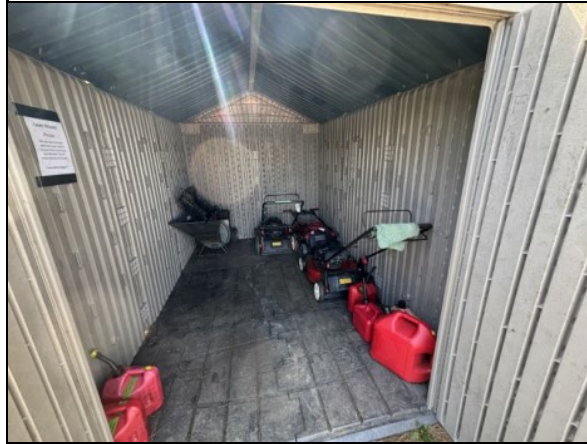
**Comp #: 537 Facilities Sheds 1st St - Repair/Replace**

**Comments:** No major damage noted of shed.

Factored here is replacement due to typical deterioration that will occur. Paint and repair as needed using general operating/maintenance funds.

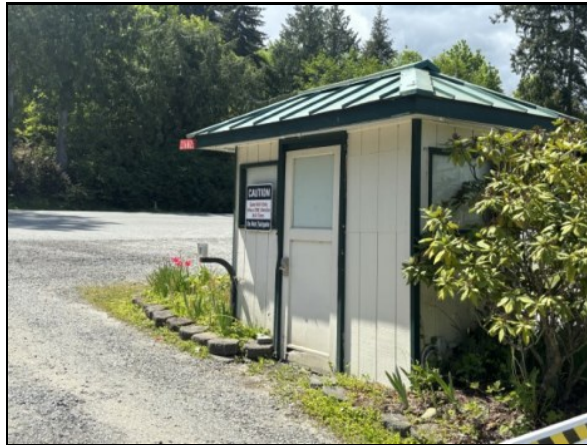
**Comp #: 538 Guardhouse Bldg - Refurbish/Replace**

**Comments:** Guardhouse is not actively utilized with no major damage/deterioration noted. Wood panel siding and metal roofing.

Factor funding for major refurbish/replacement. Maintain out of the operating budget as needed.

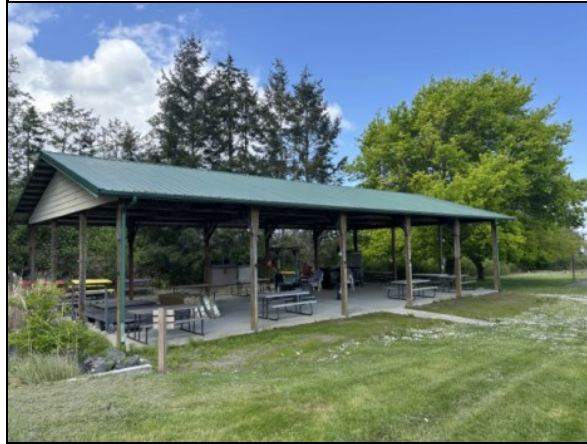
**Comp #: 540 Ramada Bldg - Replace****Approx Quantity: 1,800 GSF****Location:** General common area**Funded?:** Yes.**History:** Installed around 2005**Comments:** Ramada building is covered outdoor space open on the sides with metal roofing and supported with wood posts. Reportedly, installed around 2005. No major damage/deterioration noted.

Funding factored for replacement as shown. Maintain routinely as part of annual maintenance.

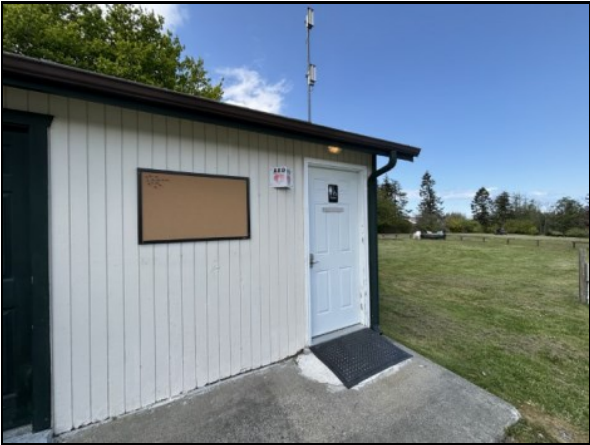
**Comp #: 552 Rstrm Structural Siding/Wdw/Replace**

**Comments:** No major problems observed of this building from visual limited inspection. Some local wear of siding but no obvious major damage noted and no problems reported to us (see #560 for paint). Positive drainage from rain and groundwater is important to protect against water intrusion at the base - inspect regularly. No obvious issues with double pane, vinyl frame windows observed during our site visit.

This type of siding is generally life limited in the 30 to 50-year range depending upon maintenance over time and exposure to weather elements. . Windows are also life limited and should be replaced at the time of siding for proper integration of waterproofing details (flashings, WRB, etc...). As useful life approaches zero, evaluate closely, including select removal to view and assess underlying structure - if still functional life can be extended with reserve plan.

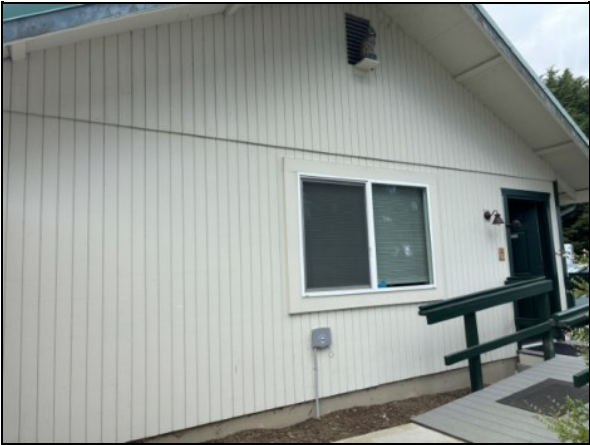
**Comments:** Some touch-up is anticipated in 2025. Overall, no widespread or major fading/wear noted of painted surfaces. In the past, some buildings have been painted individually and typically completed by on-site staff. As previously discussed with Association, we are including a funded component to repaint all buildings as comprehensive project as shown here. The cost reflects on-site staff painting so reduced cost.

As routine maintenance, inspect regularly (including sealants) repair locally, and touch-up paint as needed. Typical Northwest paint cycles vary greatly depending upon many factors including type of material painted, surface preparation, quality of primer/paint/stain, application methods, weather conditions during application, moisture beneath paint, and exposure to weather conditions. Repair areas as needed prior to painting/caulking. Proper sealant/caulking is critical to keeping water out of the walls and preventing water damage. Incorrect installations of sealant are very common and can greatly decrease its useful life. Inspect sealant (more frequently as it ages) to determine if it is failing. Typical sealant problems include failure of sealant to adhere to adjacent materials and tearing/splitting of the sealant itself. As sealants age and due to exposure to ultra-violet sunlight, they will dry out, harden, and lose their elastic ability. Remove and replace all sealant at the time sealant failure begins to appear. Proper cleaning, prep work, and installation technique (shape, size, tooling of joint) are critical for a long lasting sealant/caulking. Do not install sealant in locations that would block water drainage from behind the siding (e.g. at head flashings).

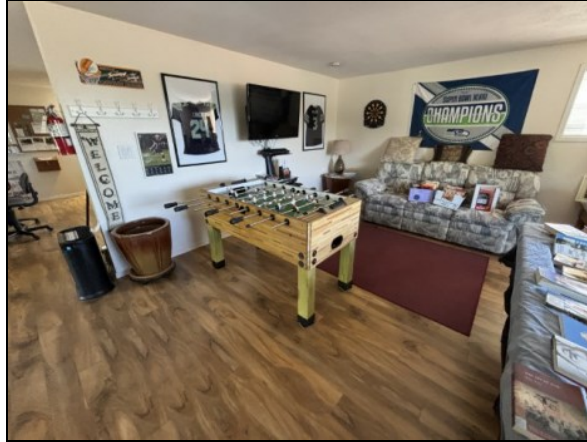
**Comp #: 701 Office/Lounge Furniture - Replace****Approx Quantity: 1 Pieces****Location:** Office / lounge building**Funded?:** Yes.**History:** Anticipated for 2025. Desk replaced in 2014**Comments:** While some variation in furnishing styles/ages, no major damage/deterioration noted. Anticipated replacement subsequent to our 2025 site visit

Prudent financial planning suggests setting aside funds for periodic large scale refurbishing to maintain consistent aesthetic, marketability. Costs can vary greatly; adjust costs below when a better estimate of replacements become known. As routine maintenance, inspect regularly and perform any needed repairs promptly using general maintenance funds.

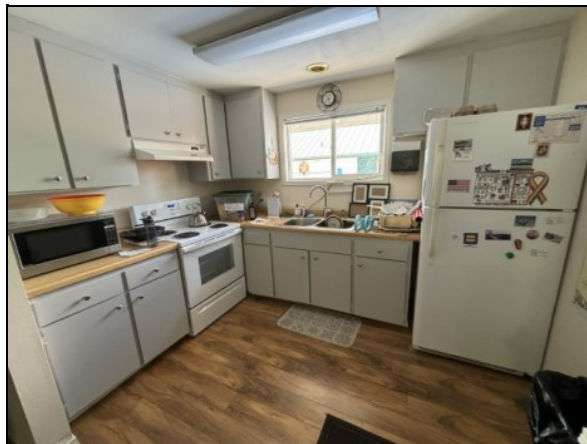
**Comp #: 702 Office/Lounge Appls - Replace 2030****Approx Quantity: 3 pieces****Location:** Kitchen area of Office/Lounge interior**Funded?:** Yes.**History:** Unknown**Comments:** Like our previous site visit, no major issues/problems reported of appliances, however older; refrigerator, stove/range, microwave, refrigerator and freezer.

Prudent planning suggests setting aside funds for the periodic replacement of appliances at regular intervals to maintain function. Clean, maintain, and provide service as needed to extend useful life.

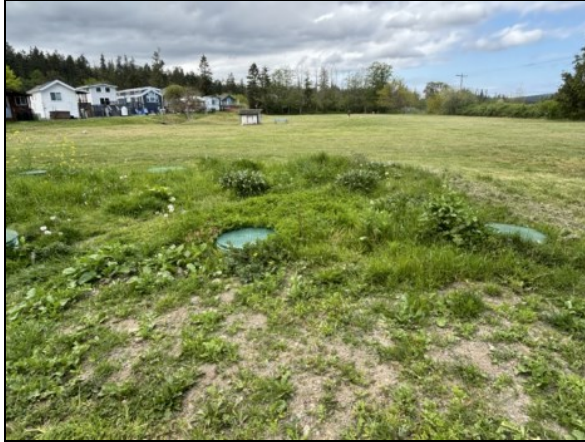
**Comments:** Due to failure of originally installed, antiquated septic system, the system was replaced in 2020-2021 for about \$750,000 (funded through both existing reserves and special assessment). The original system had one of the only Evapotranspiration (ET) basins. The system renovations/replacements generally consisted of (but not limited to) replacing a majority of the ET distribution laterals and trench gravel, replacing tanks with new and larger tanks to allow for flow equalization, adding a treatment system and a new control panel to allow for timed dosing to the sub-surface dripfield. While difficult to estimate major capital needs for this system going forward, using plans/specifications and other resources, we have included funding for some specific components within this reserve study.

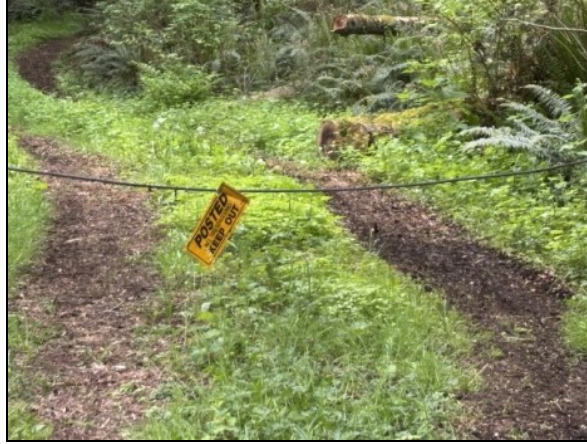
**Comments:** The subsurface drip dispersal area includes 20,000 LF of dripper line with auto flush return and six zone manifold comprised of solenoid valves. According to the Client, problems with the system function specifically having to do with filtering and draining area have been identified. The Client is working with the Department of Health to determine best course of action. At this point, while work to the system will be needed, not enough information to include funding. This component should be adjusted once information is known.

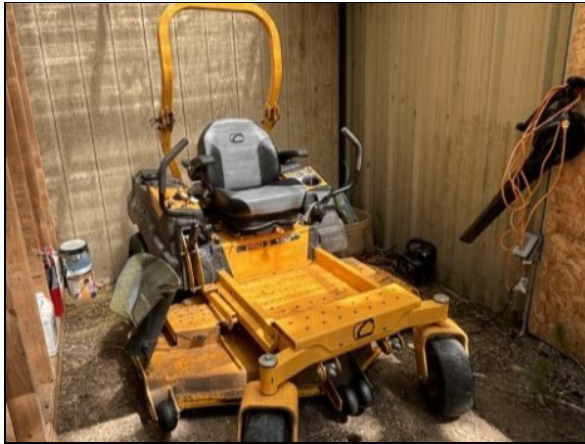
**Comp #: 952 Zero Turn Mower - Replace**

**Comments:** Reported this piece has high usage and replacement moved up in this reserve study. Have serviced as part of annual operating budget.

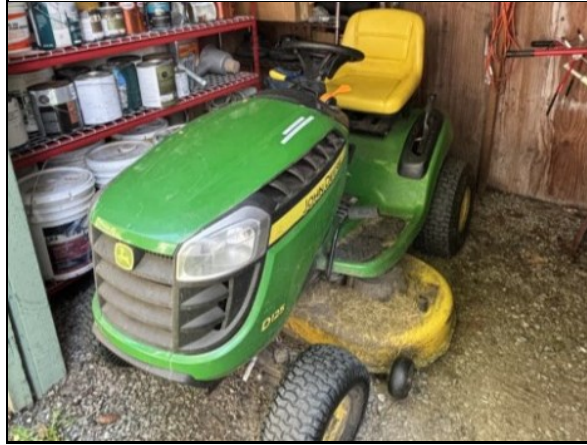
**Comp #: 953 John Deere Riding Mower - Replace**

**Comments:** No problems reported of this piece. Funding included for replacement. Have serviced as part of annual operating budget.

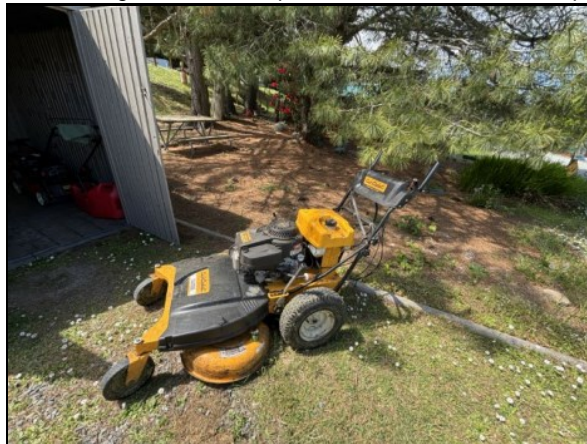
**Comp #: 955 Walk Behind Mower - Replace**

**Comments:** No problems reported. Funding included for replacement. Have serviced as part of annual operating budget.

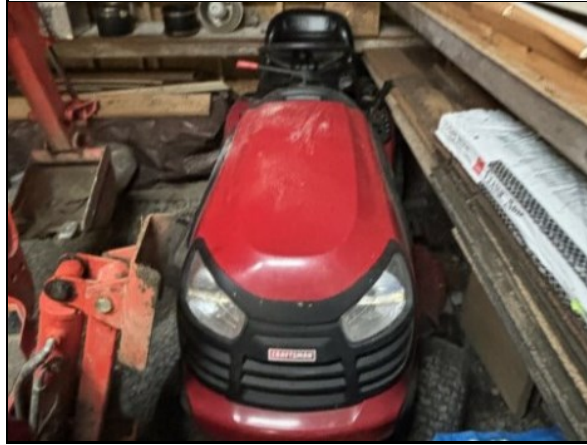
**Comp #: 956 Craftsman Mower - Replace**

**Comments:** Although no problems reported of this mower, reported to us this piece will not be replaced but removed from fleet at one point and not replaced.

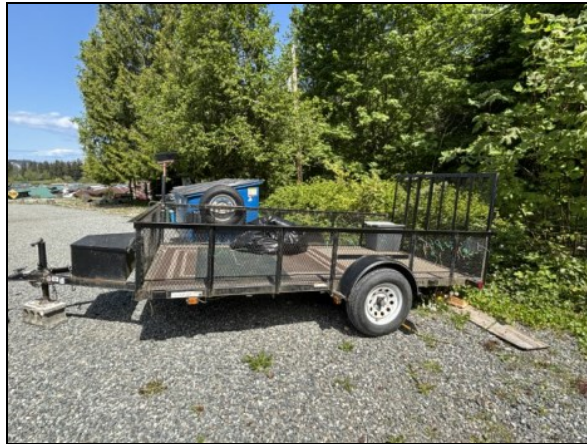
**Comp #: 960 Utility Trailer - Repair/Replace**

**Comments:** No problems reported of trailer purchased for hauling recycle. Funding included for replacement. Have serviced as part of annual operating budget.

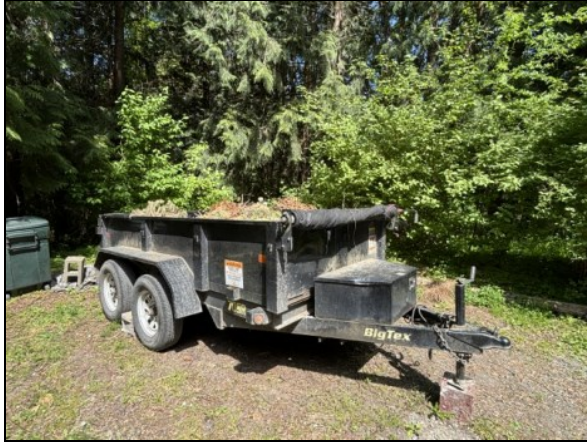
**Comp #: 961 Dump Trailer - Repair/Replace**

**Comments:** No problems reported of dump trailer generally used for yard waste. Funding included for replacement. Have serviced as part of annual operating budget.

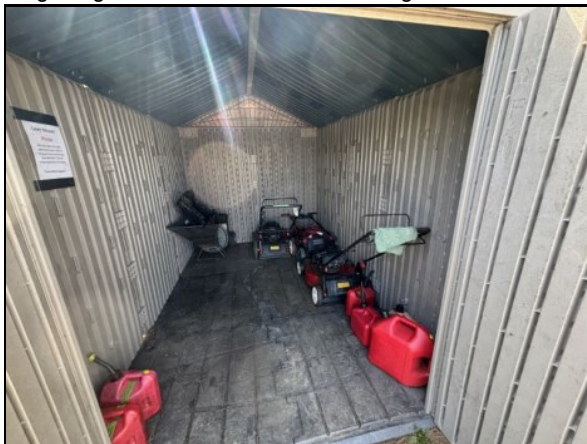
**Comp #: 962 Landscape Equipment - Replace**

**Comments:** In addition to larger mowers already funded for within this study, Association owns various smaller push mowers, blowers, weed-eaters, trimmers, etc. for Association landscape purposes. As discussed with Association, history of successfully repairing/replacing through operating budget therefore no reserve funding included.

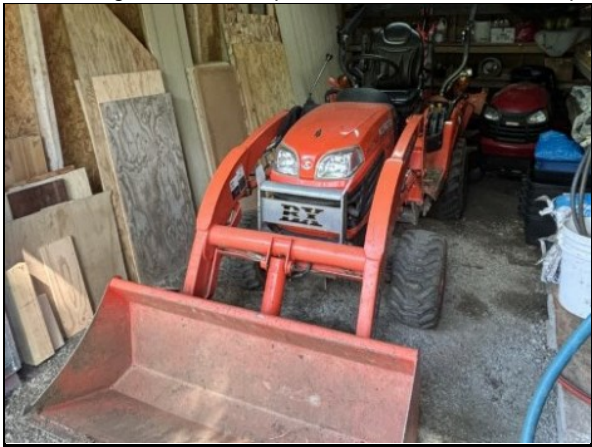
**Comp #:** 963 Tractor, Kubota - Replace

**Comments:** No problems reported. Funding included for replacement. Have serviced as part of annual operating budget.
